**US Army Corps
of Engineers®**

Notice of Preparation

Public Notice Date: 21 September 2017
Expiration Date: 05 October 2017
Reference: PME-17-09
Name: St. Maries Levee Rehabilitation

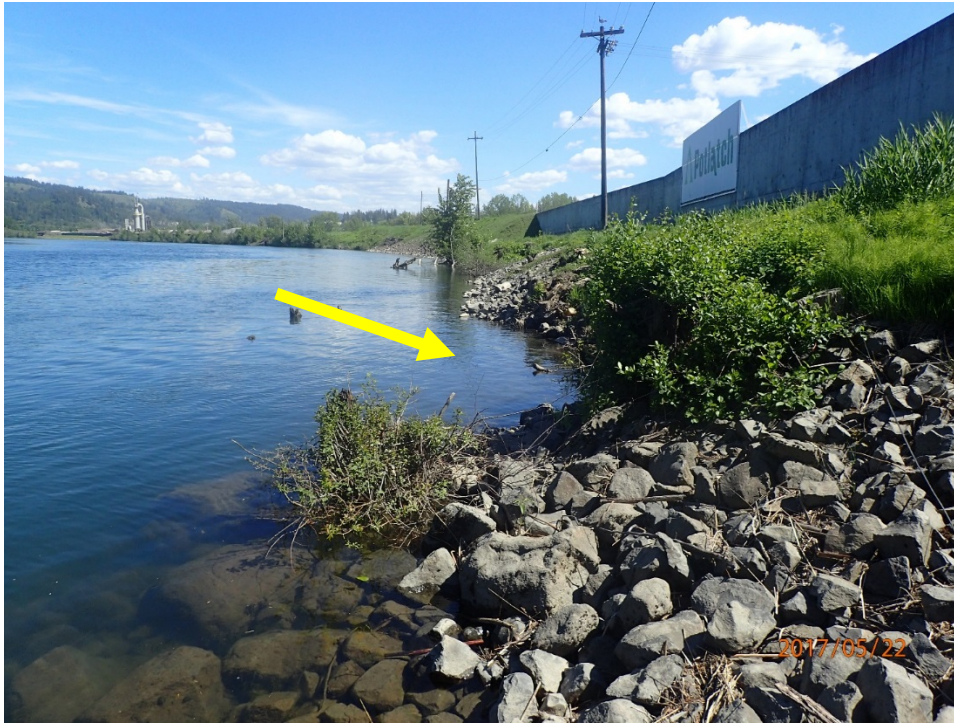
Figure 1. Site 1, scour damage in front of flood wall.

High river flows over the course of 5 days in the St. Joe River resulted in slope damage (including slope failure) and loss of toe rock. The damage is located in a continuous stretch but is separated into three sections: (1) 500 feet of toe rock lost in front of a floodwall, (2) 200 foot long slope failure, and (3) 1,300 feet of toe rock and support damage. Total length of damage is 2,000 feet. The levee requires an emergency repair prior to the upcoming St. Joe River flood season to ensure reliable flood protection for the City of St. Maries. In the damaged state, the level of protection is diminished from 1,000 year level of protection to a 3-year level of protection. The location of the damaged levee is shown in Attachment A and photographs of the damage are in Attachment B.

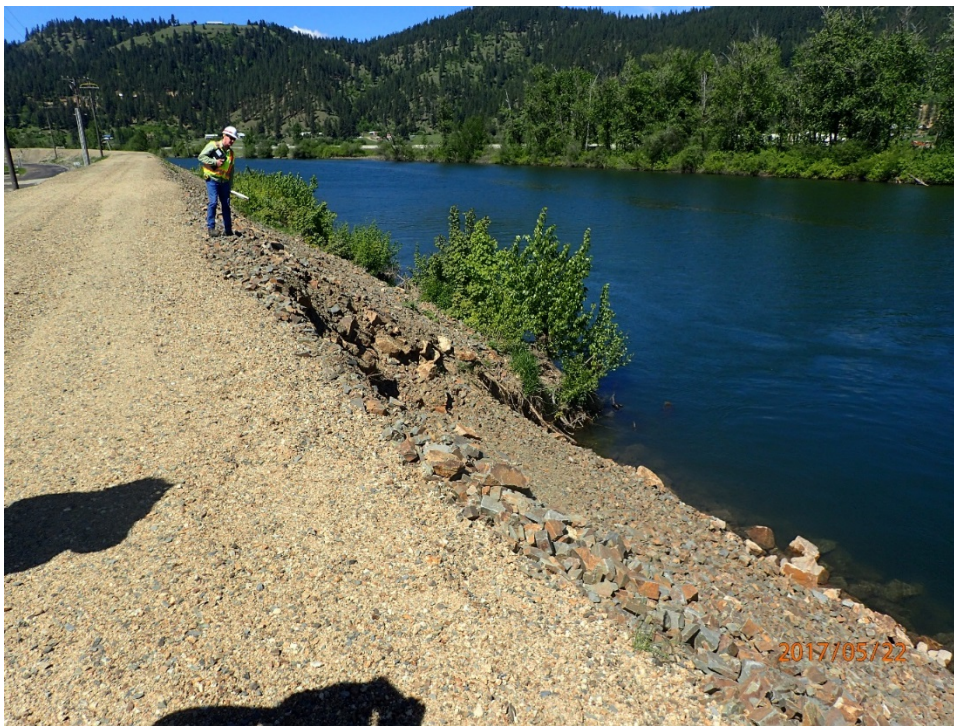
Figure 2. Site 2, slope failure viewed from levee top.

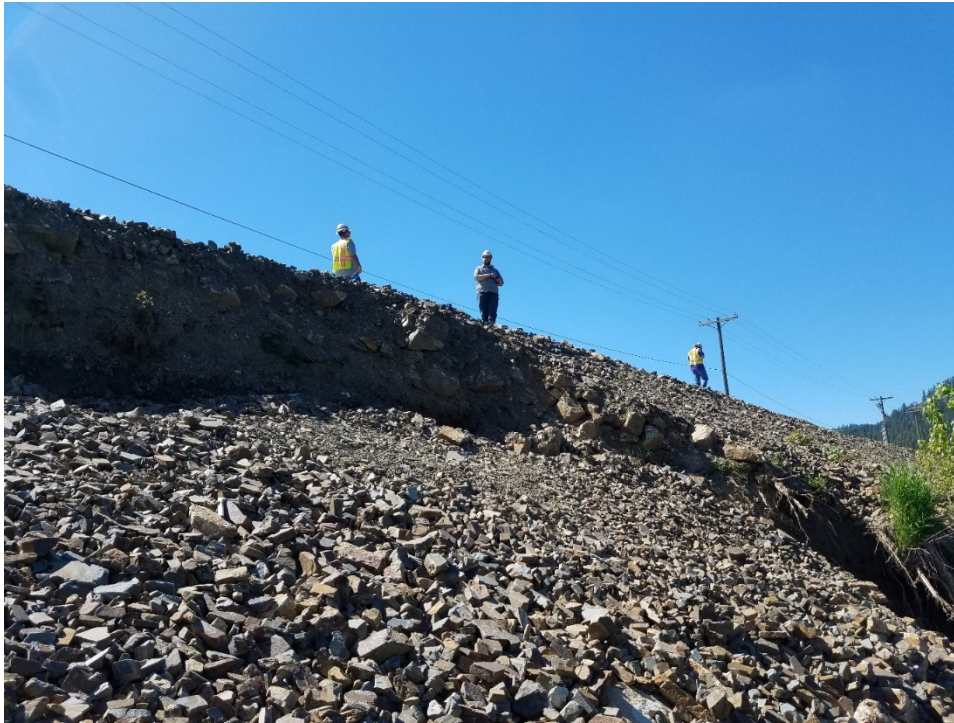
Photo 3. Site 2, slope failure as viewed from below.

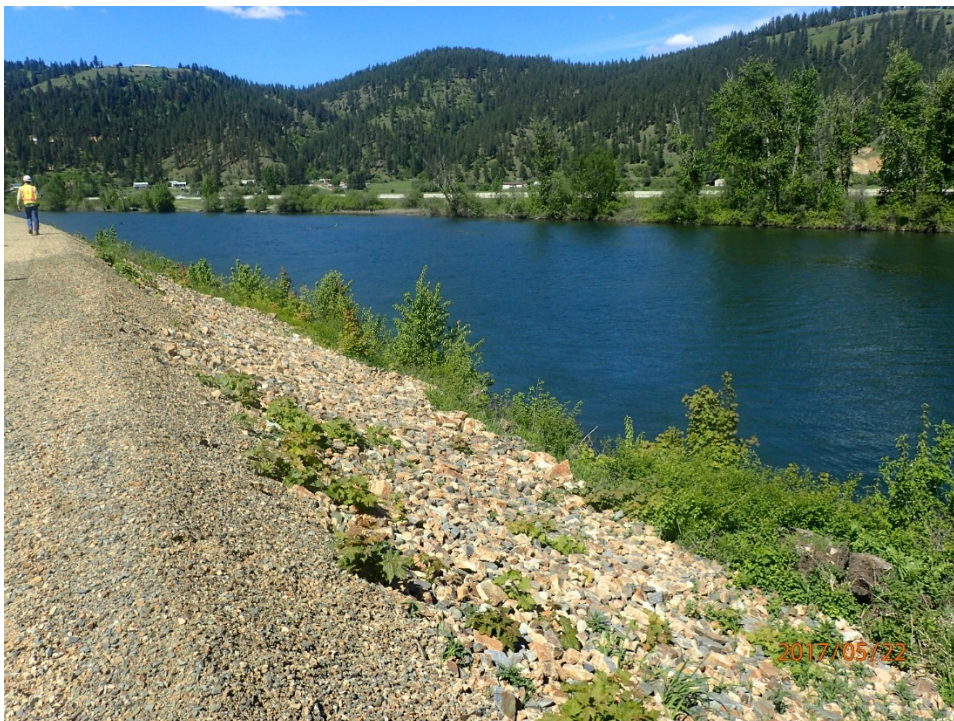
Figure 4. Site 3, toe damage (hidden by vegetation along toe and high water).

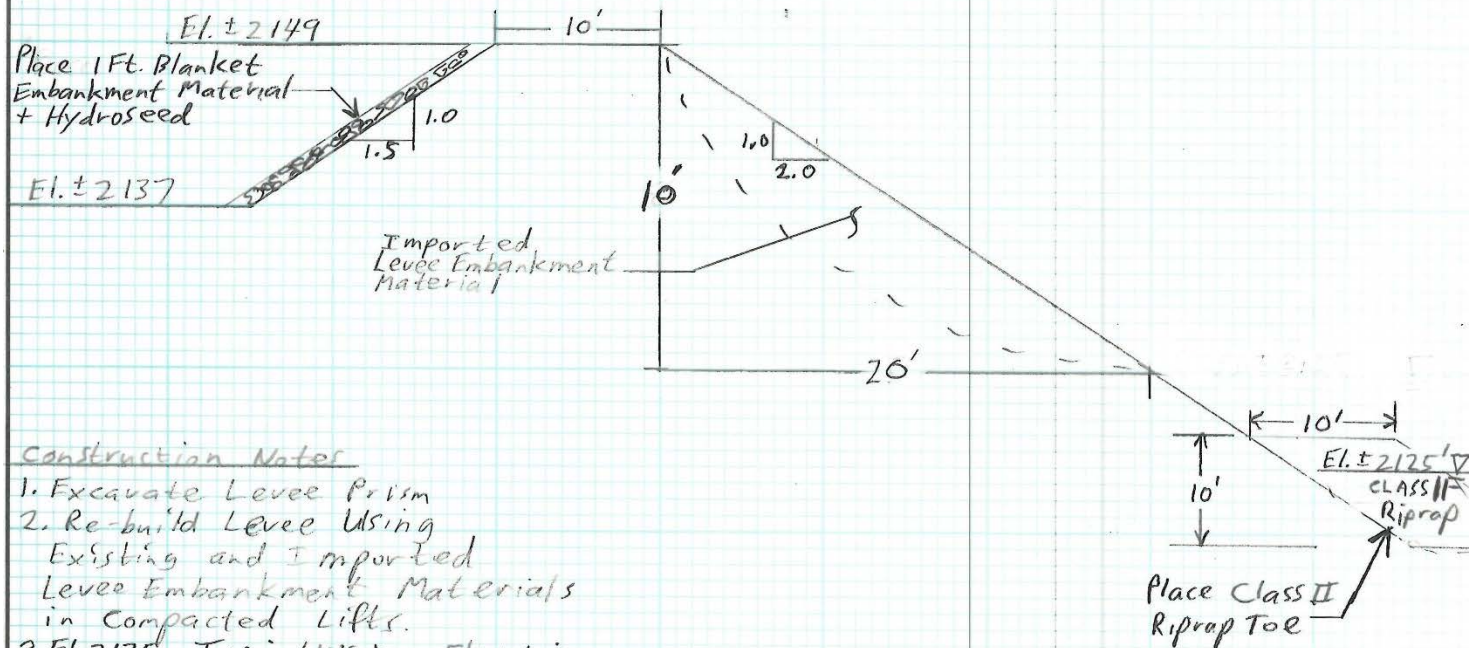
Site 2
200 feet

Construction Notes

1. Excavate Levee Prism
2. Re-build Levee Using Existing and Imported Levee Embankment Materials in Compacted Lifts.
3. El. 2125 - Typical Winter Elevation
4. Restore Riprap Armor Blanket on Riverward Slope.
5. Place Class II Riprap Toe.
6. Tie-In to Existing Riprap Upstream + Downstream
7. Hydroseed Landward Side of Levee.

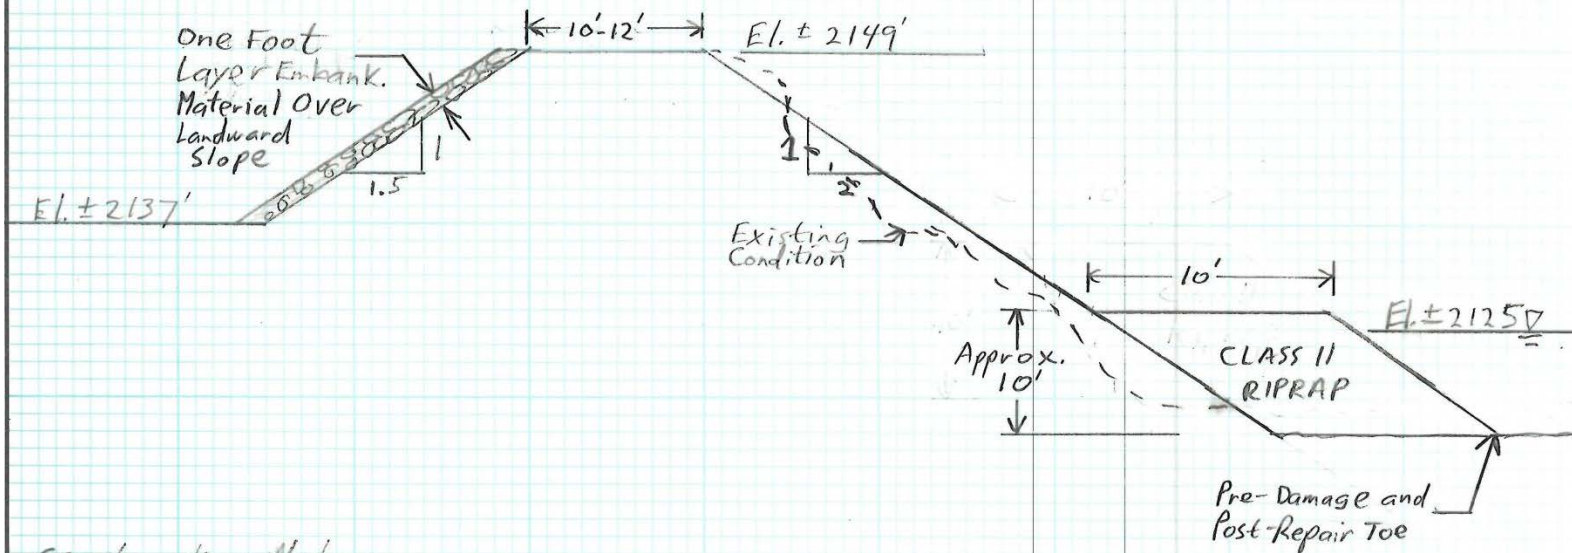
Site 3
1,300 feet

Construction Notes

1. Reshape Riverward Slope, incl. Existing Riprap Armor.
2. Place Class II Riprap At Riverward Toe.
3. Place Embankment Material Over Spalls on Landward Slope.
4. Hydroseed Landward Slope.
5. El. 2125' - Typical Winter Elevation.
6. Tie-in Riprap to Existing Armor Protection Upstream and Downstream.
